River Road ILF Project Site
LRB-2019-01207

Prepared by:
Ducks Unlimited New York In-Lieu Fee Program
LRB-2010-00673 (ILFP)

DATE: 30 June 2021

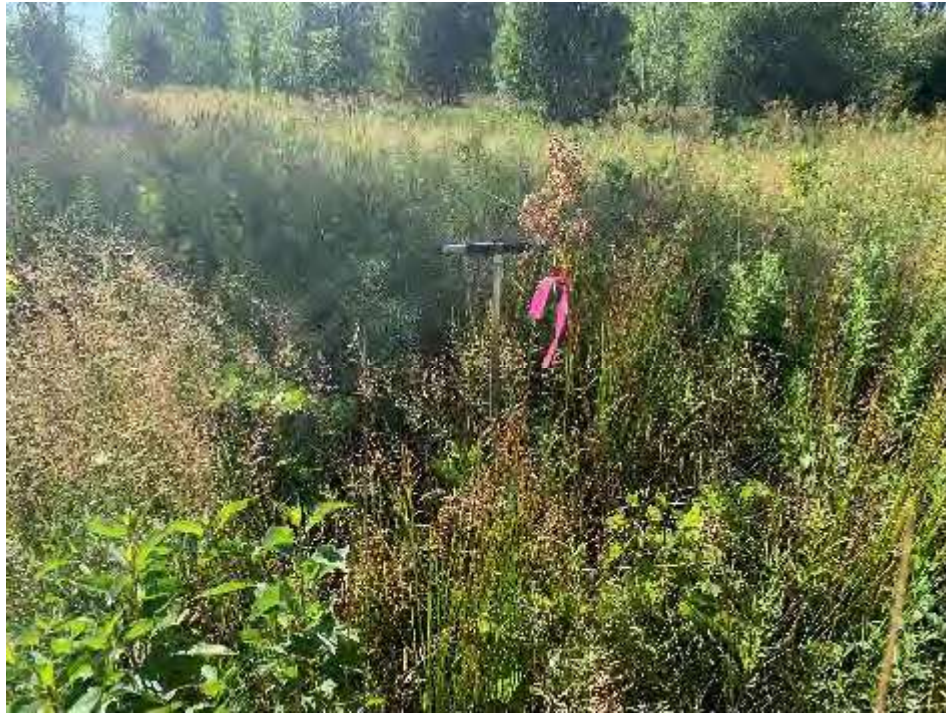
DPW11. This portion of emergent Wetland G was dominated by soft rush (*Juncus effusus*) and rough bentgrass (*Agrostis scabra*). The primary hydrology indicator was oxidized rhizospheres on living roots. A depleted matrix was the hydric soil indicator. Photo taken August 6, 2020.

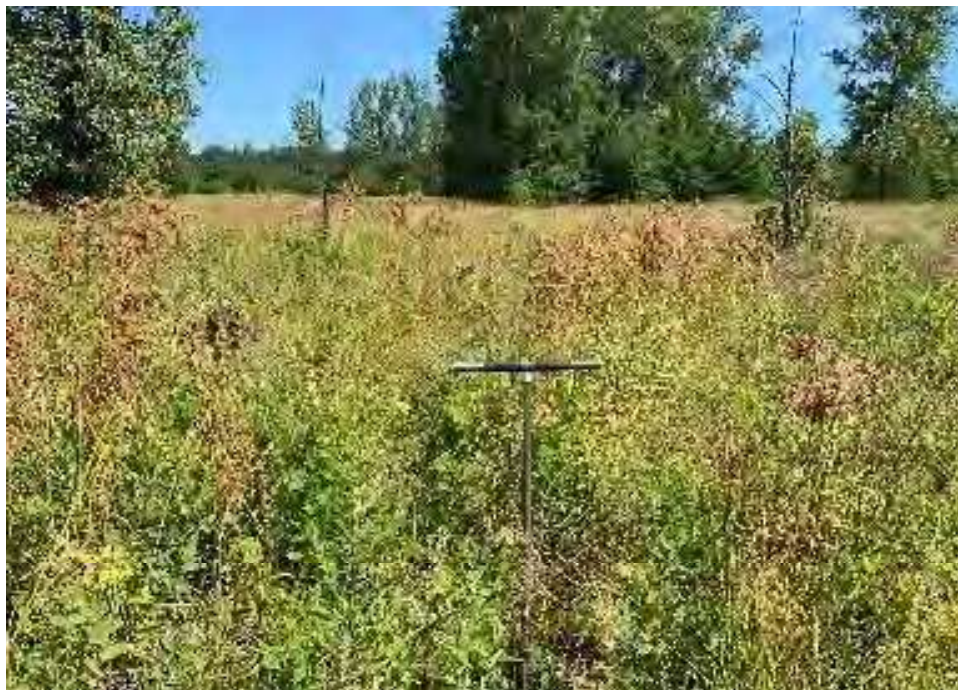
DPW12. This portion of emergent Wetland C was dominated by riverbank grape (*Vitis riparia*). The primary hydrology indicator was oxidized rhizospheres on living roots. A depleted matrix was the hydric soil indicator. Photo taken August 12, 2020.

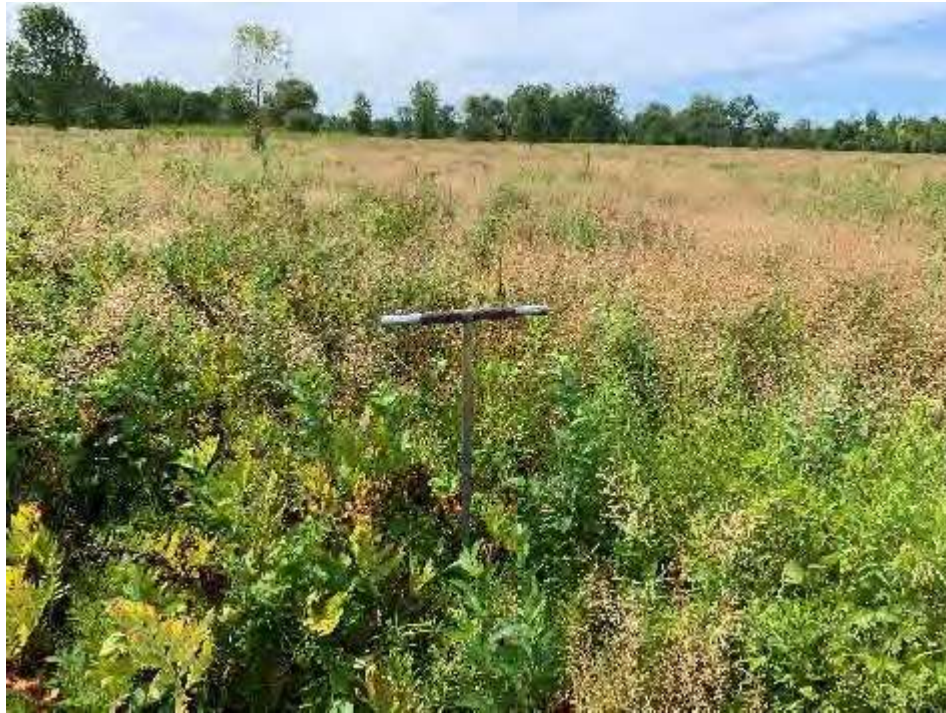
DPW13. Wetland E is a PEM/upland mosaic with the PEM component comprising 70% of the area. This portion of Wetland E was dominated by sensitive fern (*Onoclea sensibilis*) and crooked-stemmed aster (*Symphyotrichum prenanthoides*). The primary hydrology indicator was oxidized rhizospheres on living roots. Depleted below dark surface and a depleted matrix were the hydric soil indicators. Photo taken August 12, 2020.

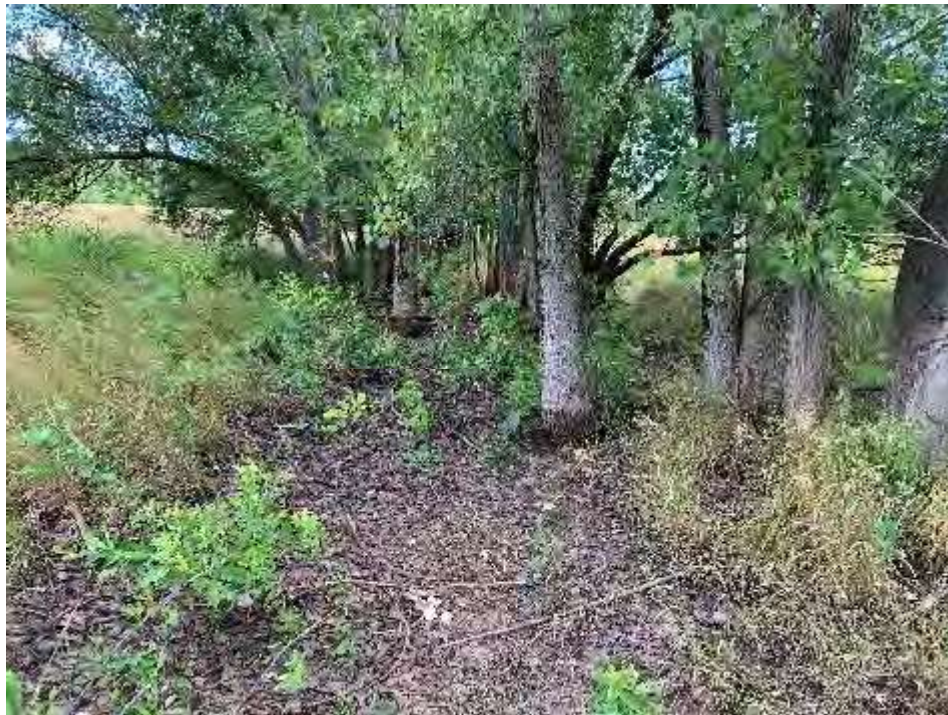
DPW14. Forested wetland D was dominated by eastern cottonwood (*Populus deltoides*) and black willow (*Salix nigra*), with green ash (*Fraxinus pennsylvanica*) and pin oak (*Quercus palustris*) in the understory. The primary hydrology indicator was oxidized rhizospheres on living roots. Depleted below dark surface, a depleted matrix, and redox dark surface were the hydric soil indicators. Photo taken August 12, 2020.

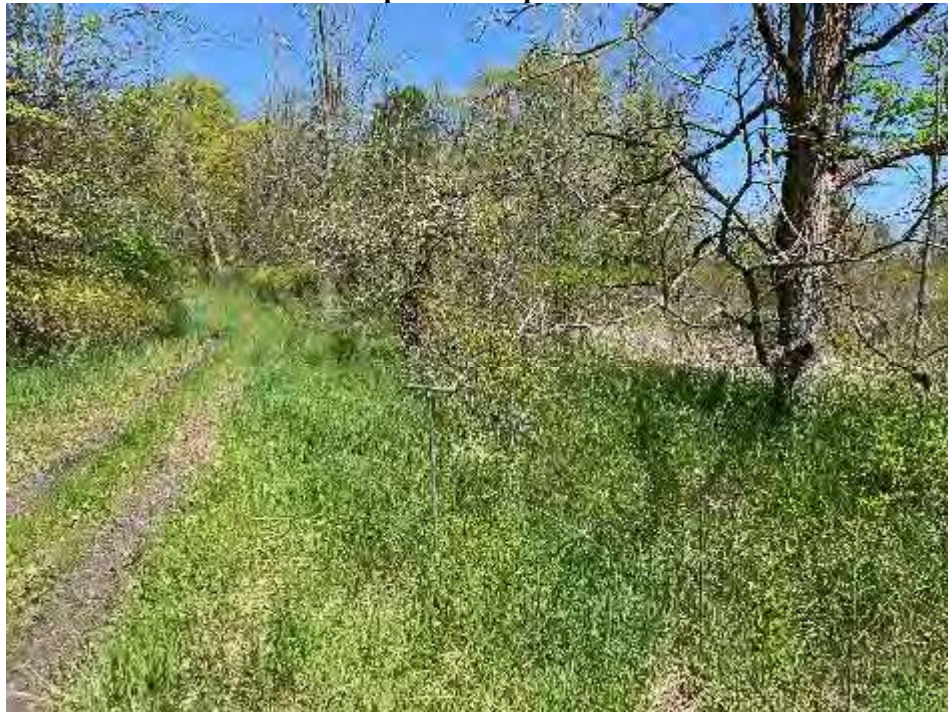
DPU1. This area, adjacent to the Niagara Scenic Parkway, was dominated by black walnut (*Juglans nigra*), gray dogwood (*Cornus racemosa*), and reed canary grass (*Phalaris arundinacea*). Photo taken May 22, 2020.

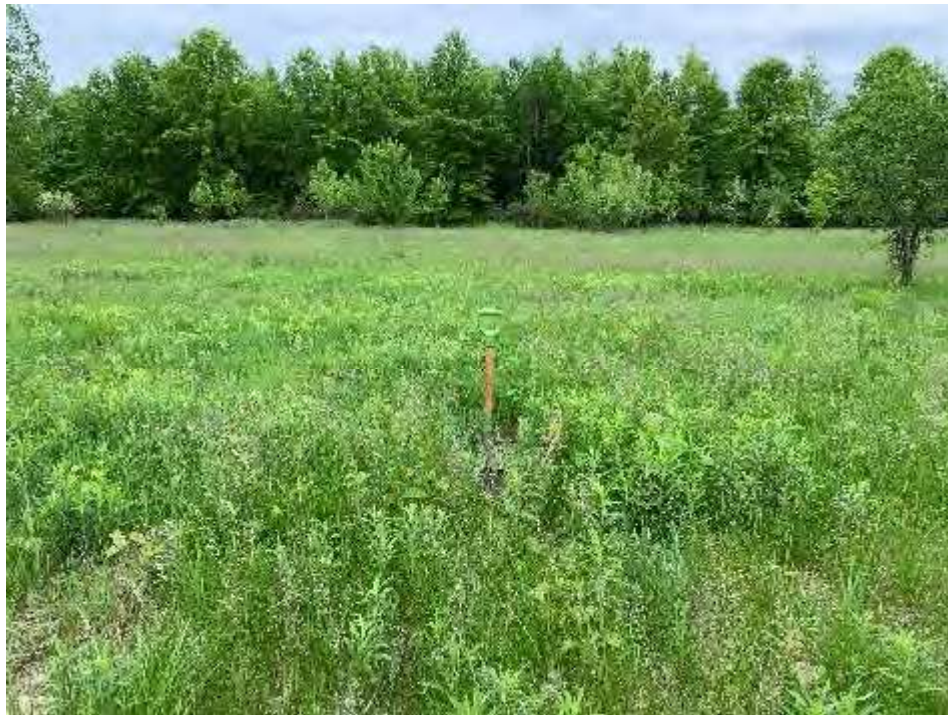
DPU2. This area was dominated by rough bentgrass (*Agrostis scabra*) and Canada goldenrod (*Solidago canadensis*). Photo taken June 2, 2020.

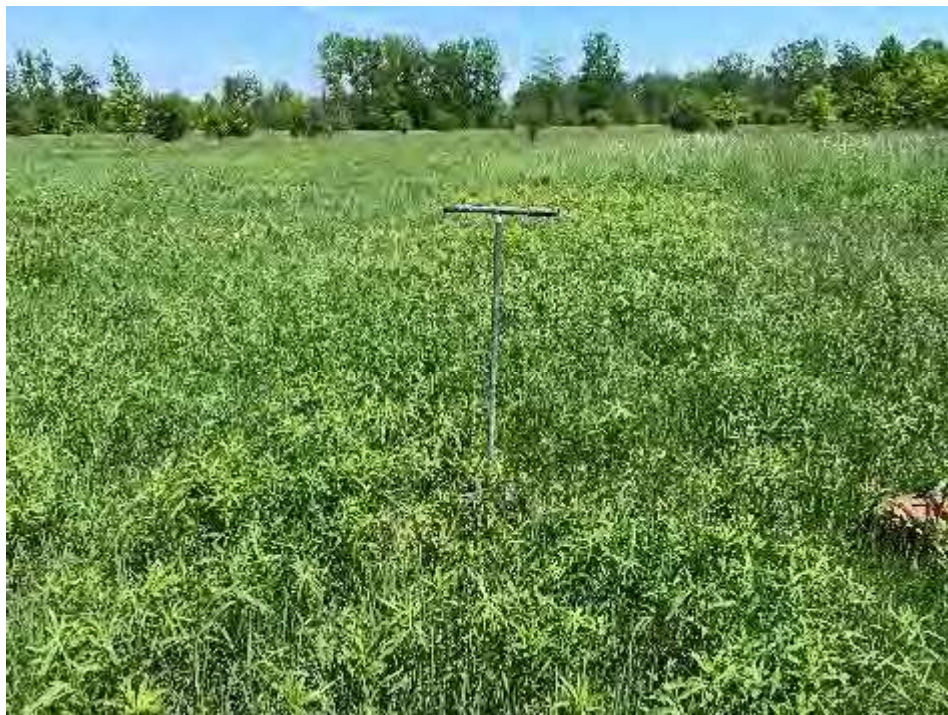
DPU3. This area was dominated by rough bentgrass (*Agrostis scabra*) and Canada goldenrod (*Solidago canadensis*). Photo taken June 4, 2020.

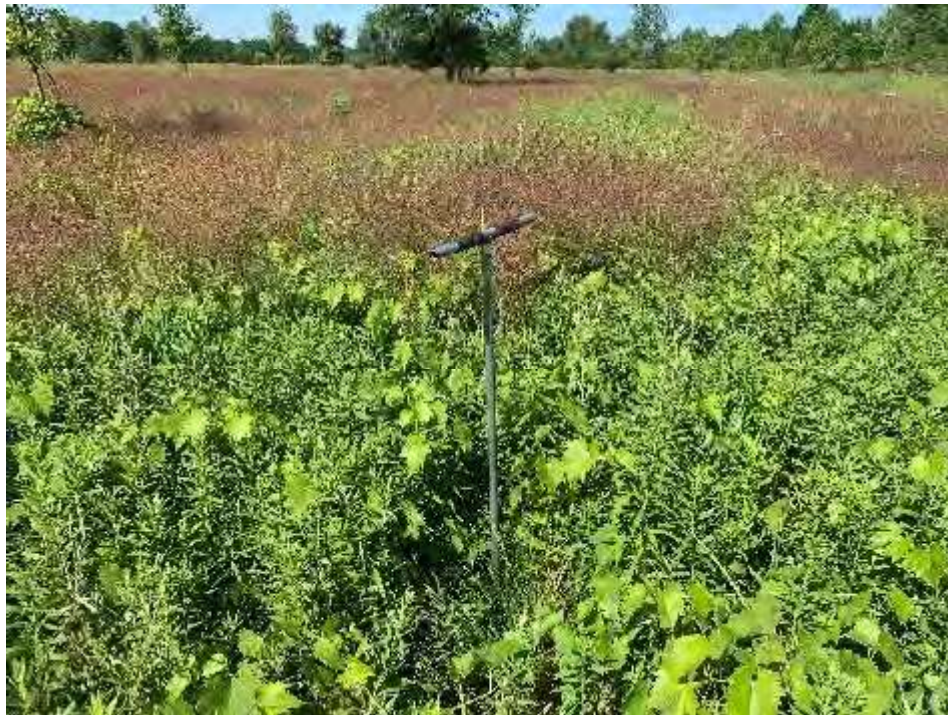
DPU4. This area was dominated by Canada goldenrod (*Solidago canadensis*), rough bentgrass (*Agrostis scabra*), and riverbank grape (*Vitis riparia*). Photo taken July 17, 2020.

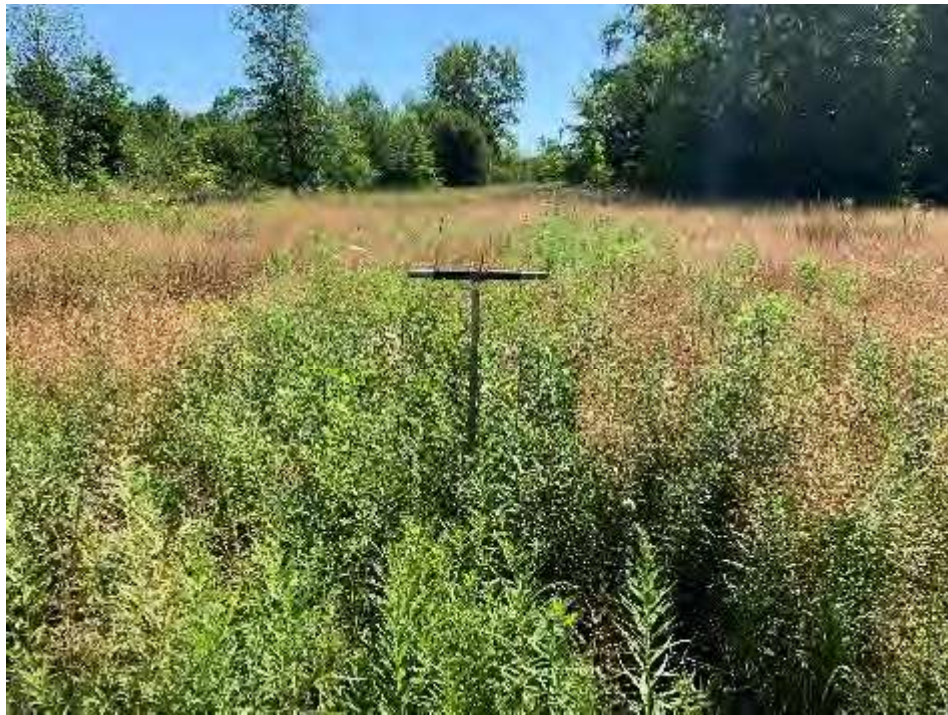
DPU5. This area was dominated by Canada goldenrod (*Solidago canadensis*). Photo taken July 28, 2020.

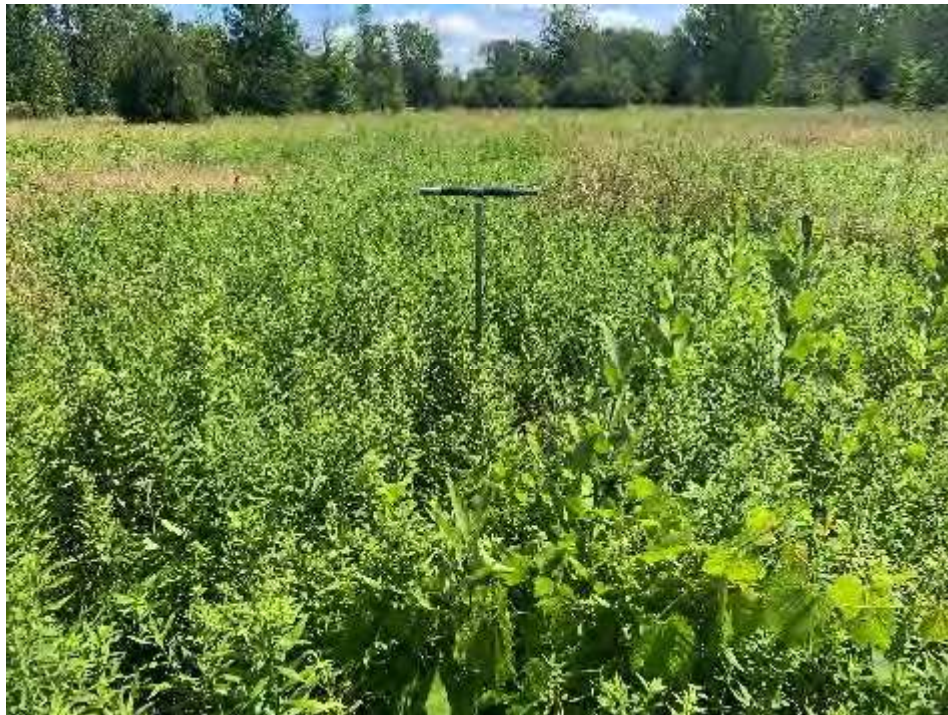
DPU6. This area was dominated by Canada goldenrod (*Solidago canadensis*) and Kentucky bluegrass (*Poa pratensis*). Photo taken August 6, 2020.

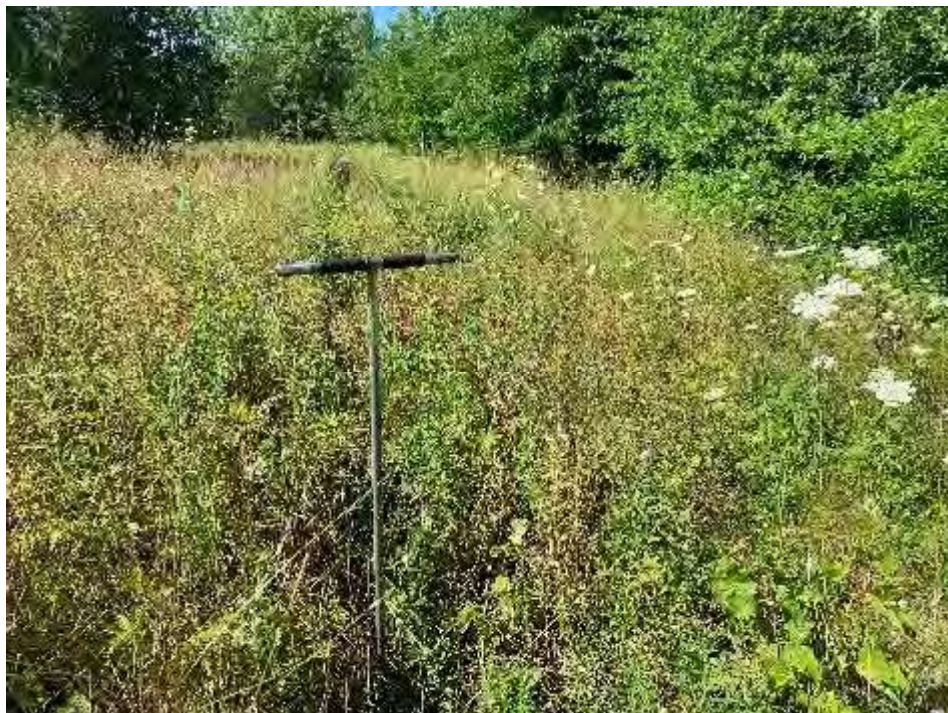
DPU7. This area was dominated by Canada goldenrod (*Solidago canadensis*), riverbank grape (*Vitis riparia*), and spotted knapweed (*Centaurea stoebe*). Photo taken August 6, 2020.

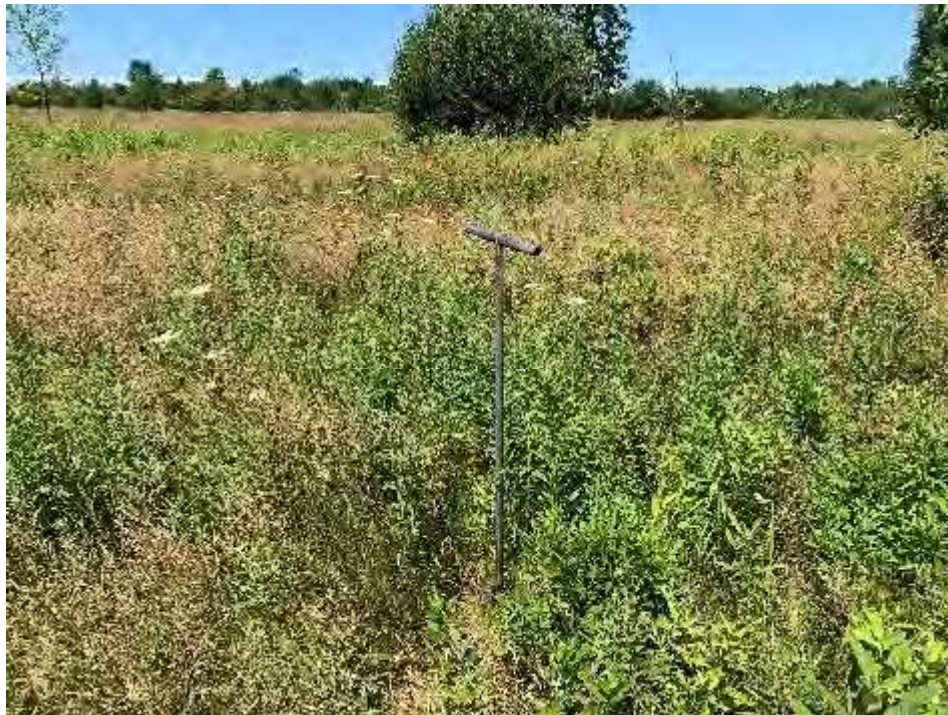
DPU8. This area was dominated by rough bentgrass (*Agrostis scabra*) and Canada goldenrod (*Solidago canadensis*). Photo taken August 7, 2020.

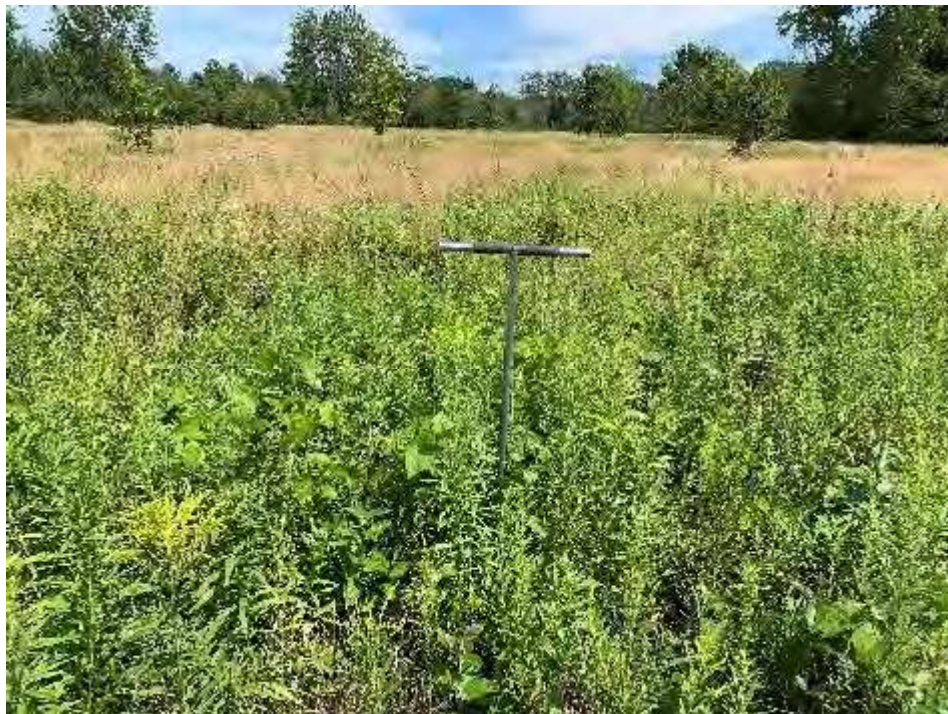
DPU9. This upland area within a PEM/upland mosaic (Wetland E) was dominated by Canada goldenrod (*Solidago canadensis*). Photo taken August 12, 2020.

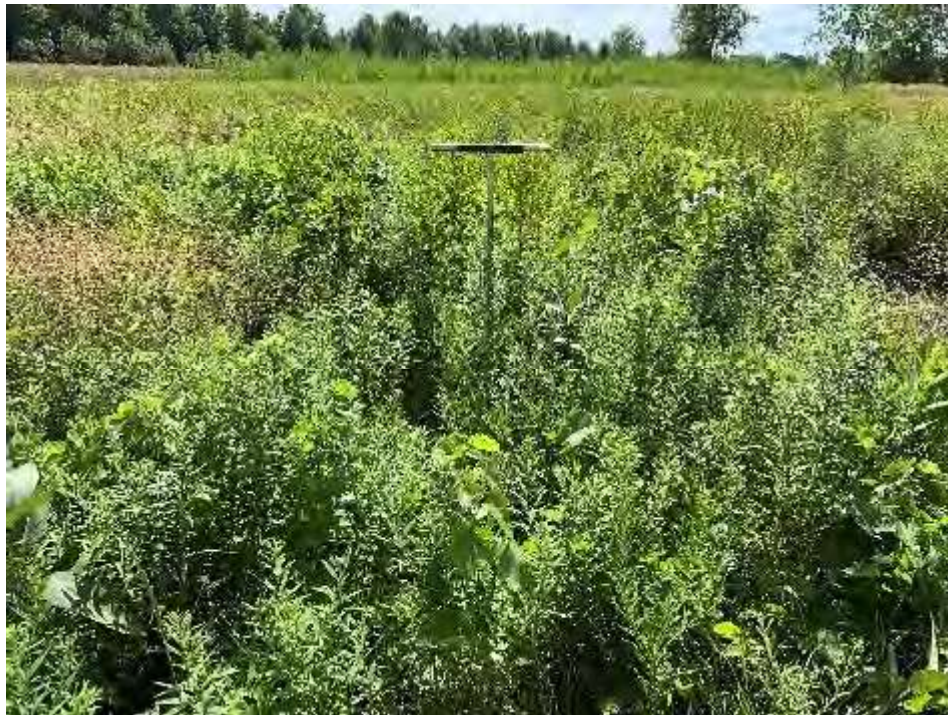
DPU10. This area was dominated by Canada goldenrod (*Solidago canadensis*), riverbank grape (*Vitis riparia*), and Kentucky bluegrass (*Poa pratensis*). Photo taken August 12, 2020.

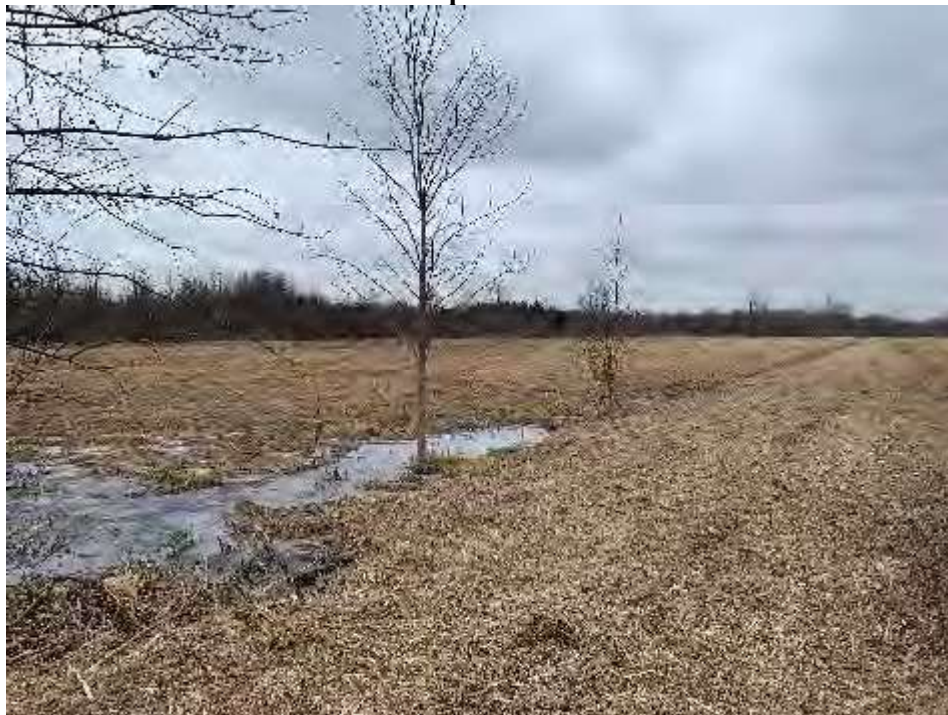
Ditch D-1. Facing east along north side of the old roadbed. Approximately 1,570 linear feet (LF), 2 feet wide and 6" deep. Photo taken January 29, 2020.

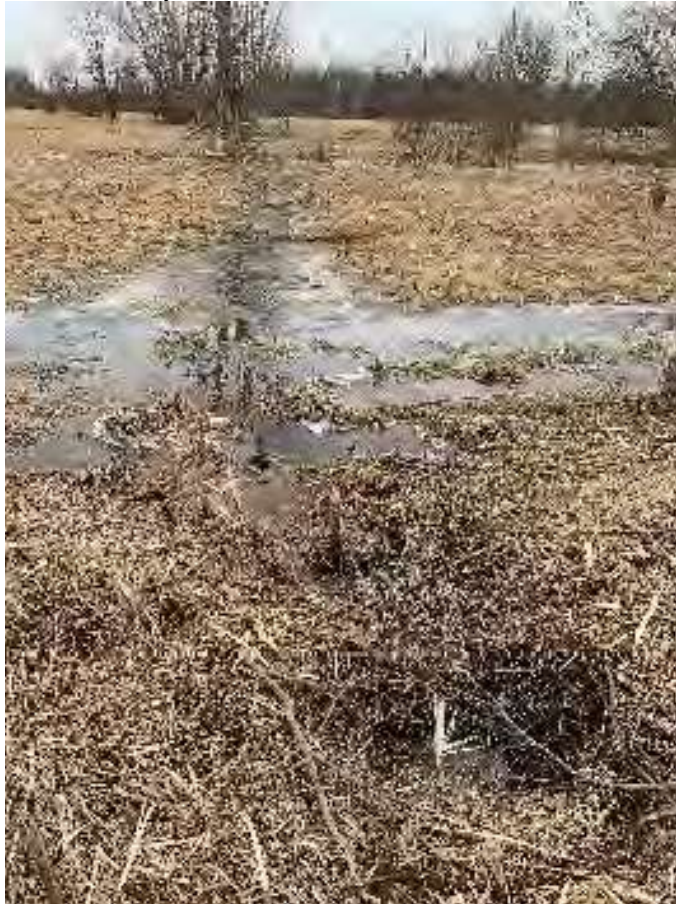
Ditch D-2. Facing south from culvert inlet. Old corrugated metal culvert to be removed. Approximately 184 linear feet (LF), 2 feet wide and 6" deep. Photo taken January 29, 2020.

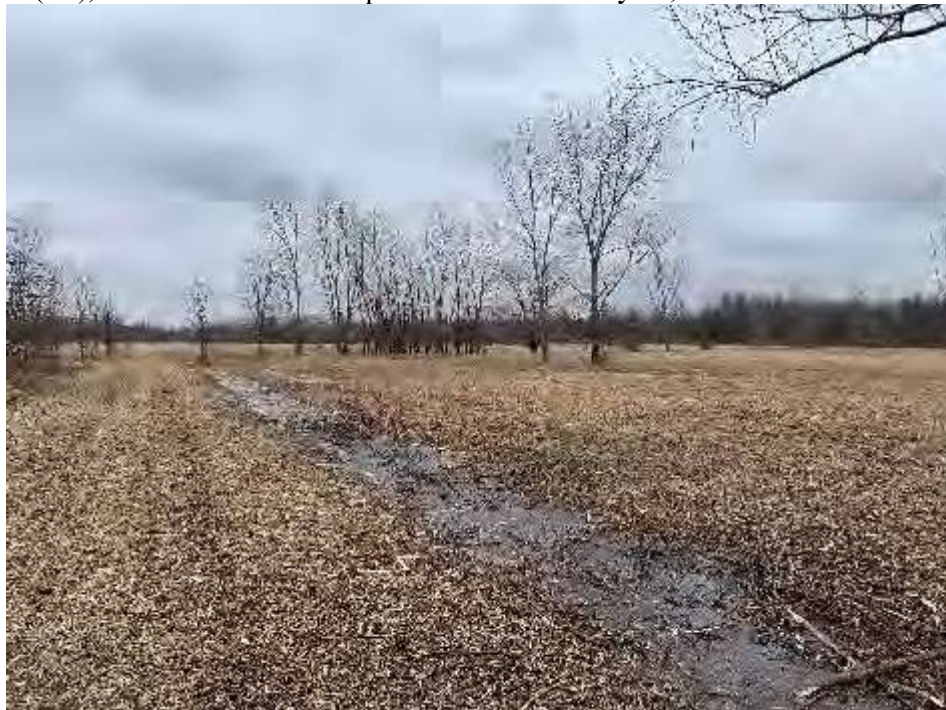
Ditch D-3. Facing east along the south side of the old roadbed. Approximately 1,676 linear feet (LF), 2 feet wide and 12" deep. Photo taken January 29, 2020.

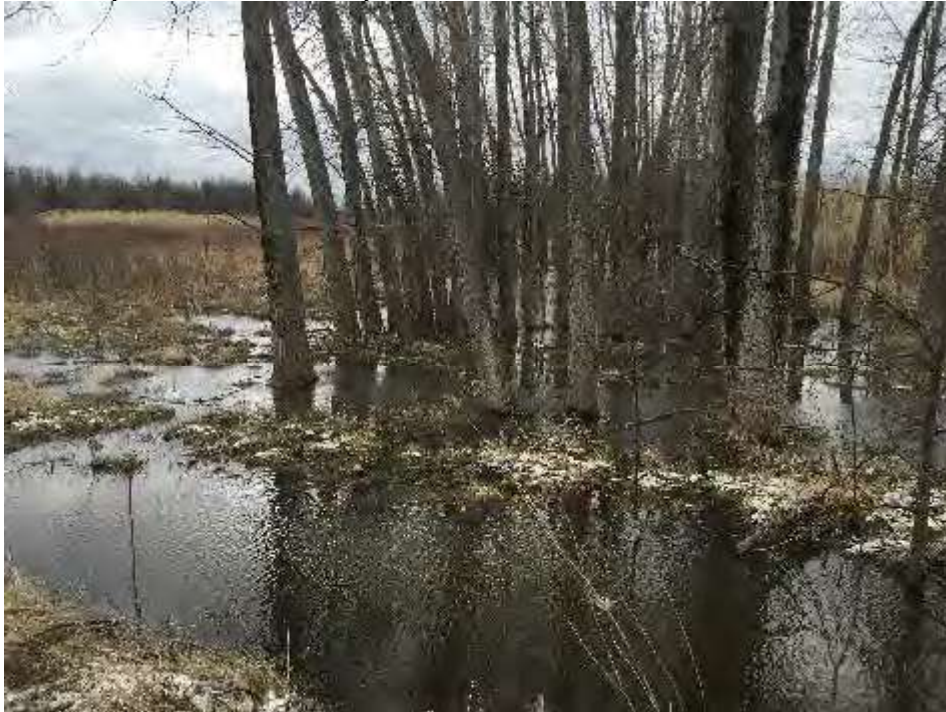
Ditch D-4. Facing south from the old roadbed. Approximately 695 linear feet (LF), 5 feet wide and 6" deep. Photo taken March 2016.

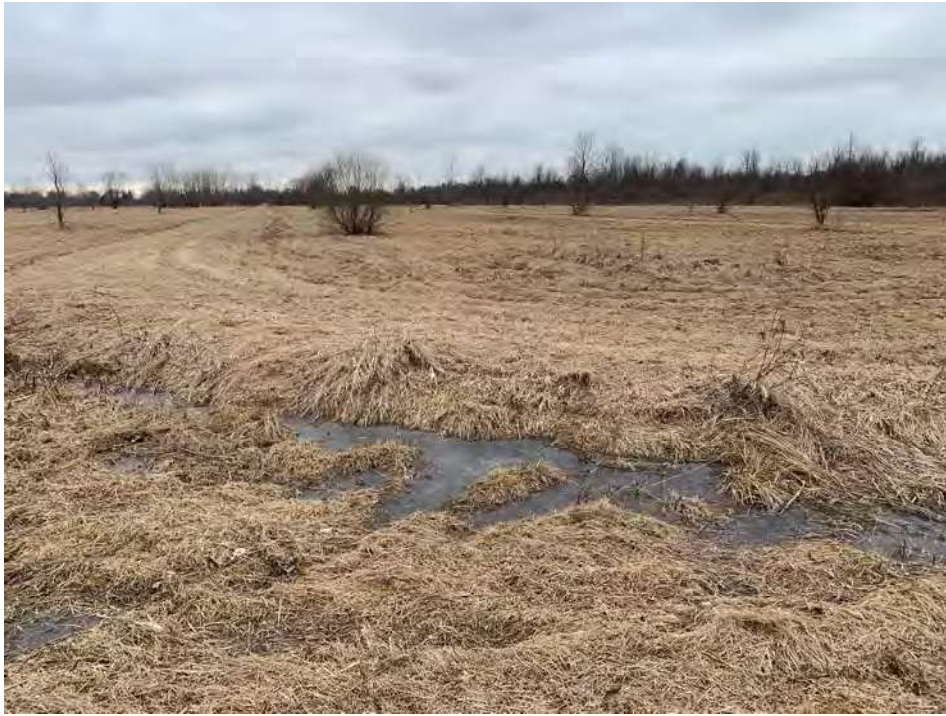
Ditch D-5. Upstream end, facing west along the old roadbed. Approximately 1,246 linear feet (LF), 2 feet wide and 12" deep. Photo taken January 29, 2020.
